# Naval Research Laboratory

NRL/MR/7333--96-7725

## Fungal Contamination of H-53 Aircraft

DENNIS M. LAVOIE  
BRENDA J. LITTLE

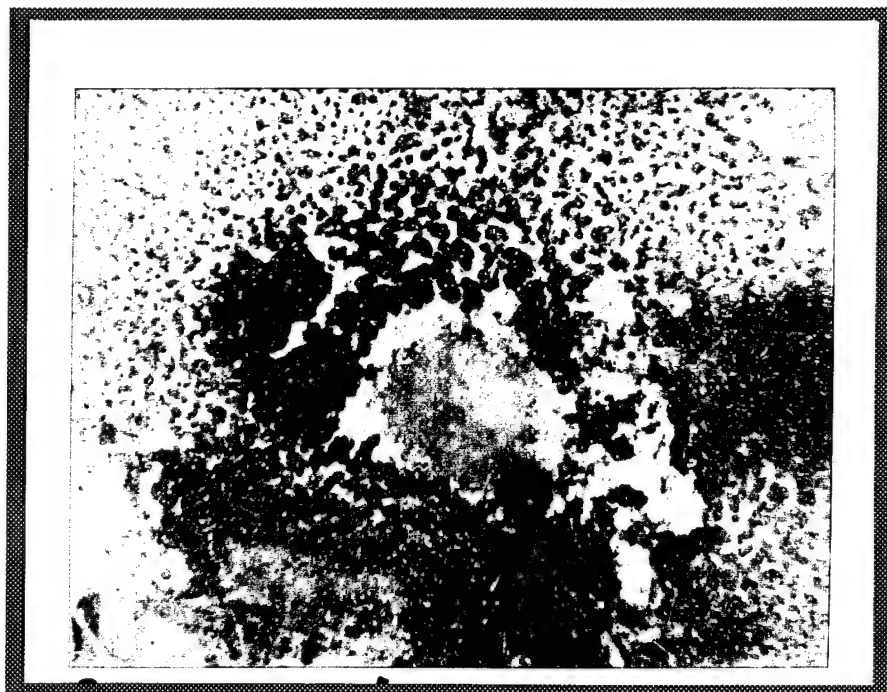
During sample collection, two types of growths were obvious to the unaided eye: black, oily-looking spots/masses (Figure 3) and drier-looking black spots/masses having a growth pattern radiating from the center (Figure 4). The oily colonies exhibited no conidia or mycelia and presented an impenetrable surface to ESEM analysis. The presence of microorganisms in this type of mass could not be confirmed by microscopy. On the other hand, the dry, radiating colonies were obviously fungal with recognizable conidia. Figure 5a shows fungal mycelia (masses of hyphae or individual filaments of cells) attached to a polyurethane paint surface, as well as a large amount of adhering, mostly mineral, debris. Figure 5b is a higher magnification that shows individual cells in hyphae and conidia (specialized cells containing one or more spores). When a colony was wiped off painted aluminum, the paint underneath appeared to be intact. When a similar colony growing on painted fiberglass was wiped, paint under the colony, but not surrounding it, was removed as well.

Figure 3: Oily type of fungus found on H-53 polyurethane coated interior surfaces. Note paint was removed when center of mass was removed (painted fiberglass) (6x).

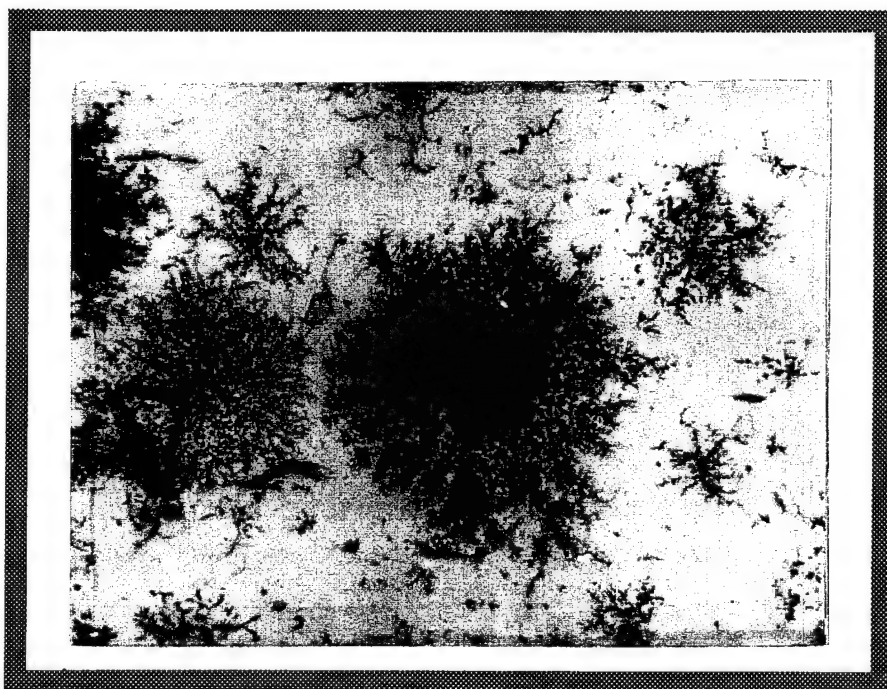
Figure 4: Dry type fungal growth on polyurethane coated aluminum (6x).

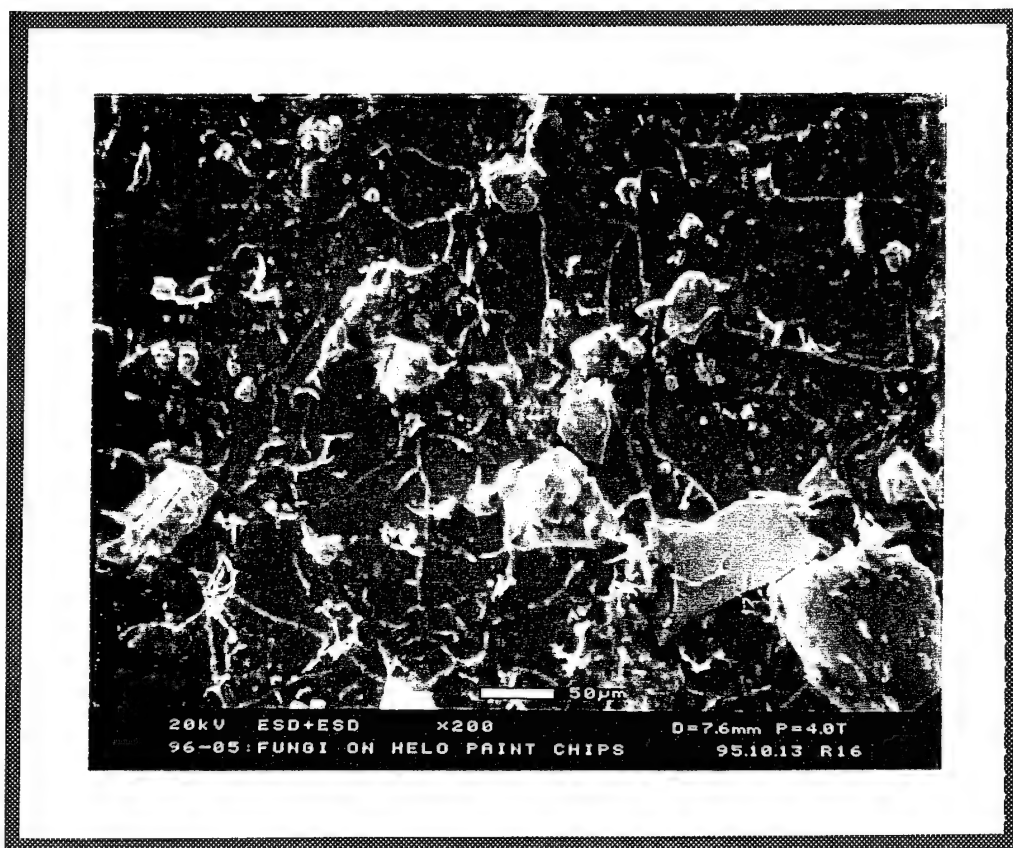
Figure 5a: Fungi and debris on polyurethane paint on interior of H-53 (200x).

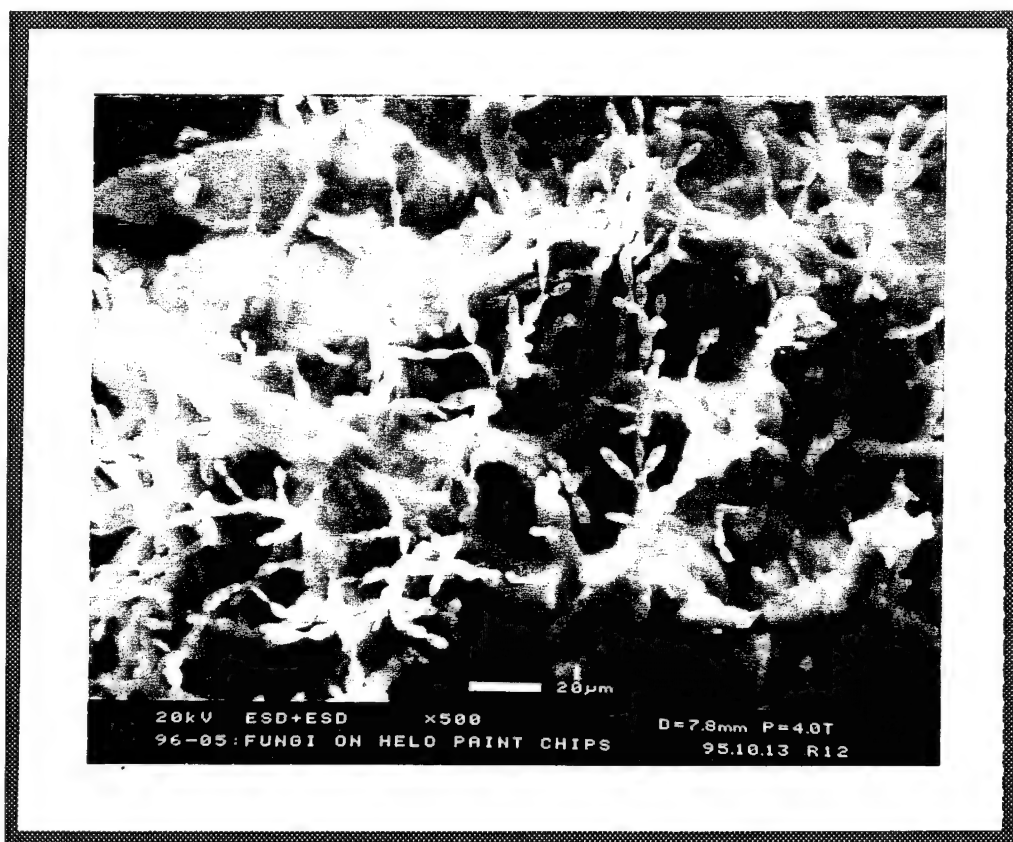
Figure 5b: Fungal mass on polyurethane paint surface (500x).

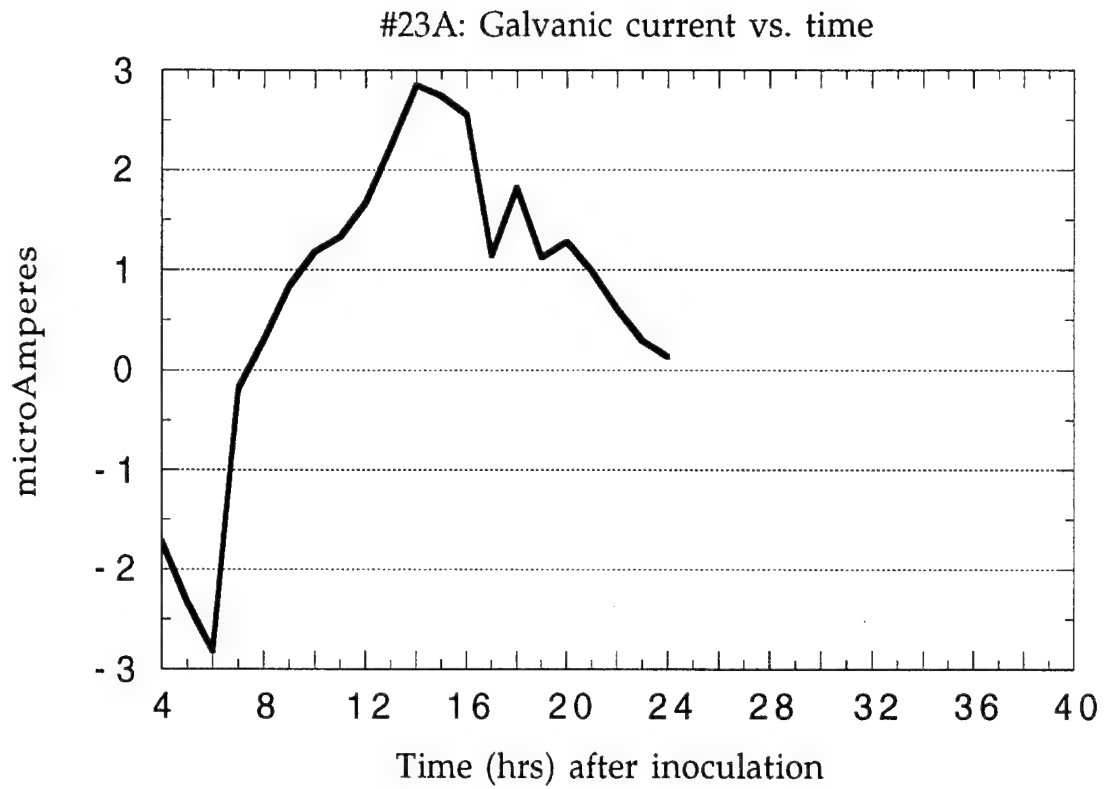
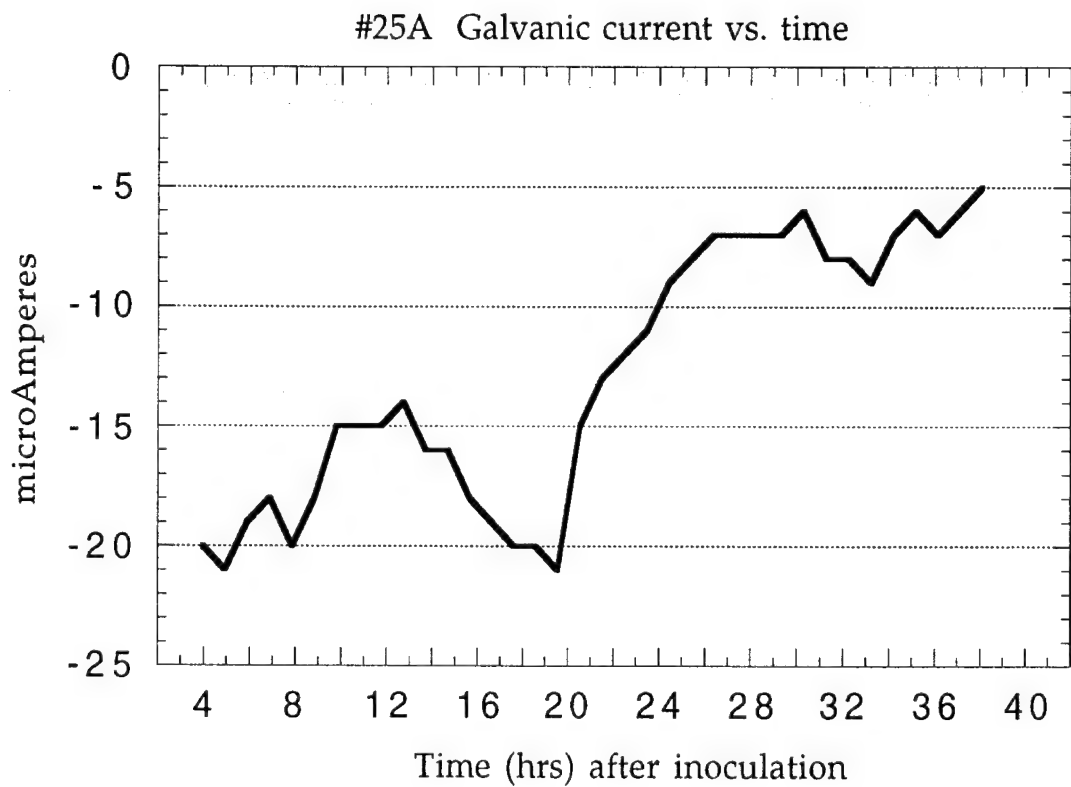
Figure 7: Galvanic currents in 2024 aluminum alloy in electrochemical test cells.

Galvanometer current and polarity results are preliminary but suggest that at least two fungal isolates are capable of causing corrosion of aluminum. Figure 7a & b. As described in Methods, cells were set up such that a positive current (i.e., anodic, giving up electrons) indicated that corrosion was occurring on the coupon inoculated with fungi. The cell inoculated with isolate 23A (*Aureobasidium*) went from cathodic (negative current) to anodic (positive current) during the course of the experiment. The cell inoculated with isolate 25A (*Trichoderma*) exhibited a trend toward anodic conditions, although a transition was never actually achieved. ESEM examination of the coupons revealed the surfaces were heavily coated with oxide with little visible evidence of mycelial growth, so the exact nature of attack could not be confirmed.

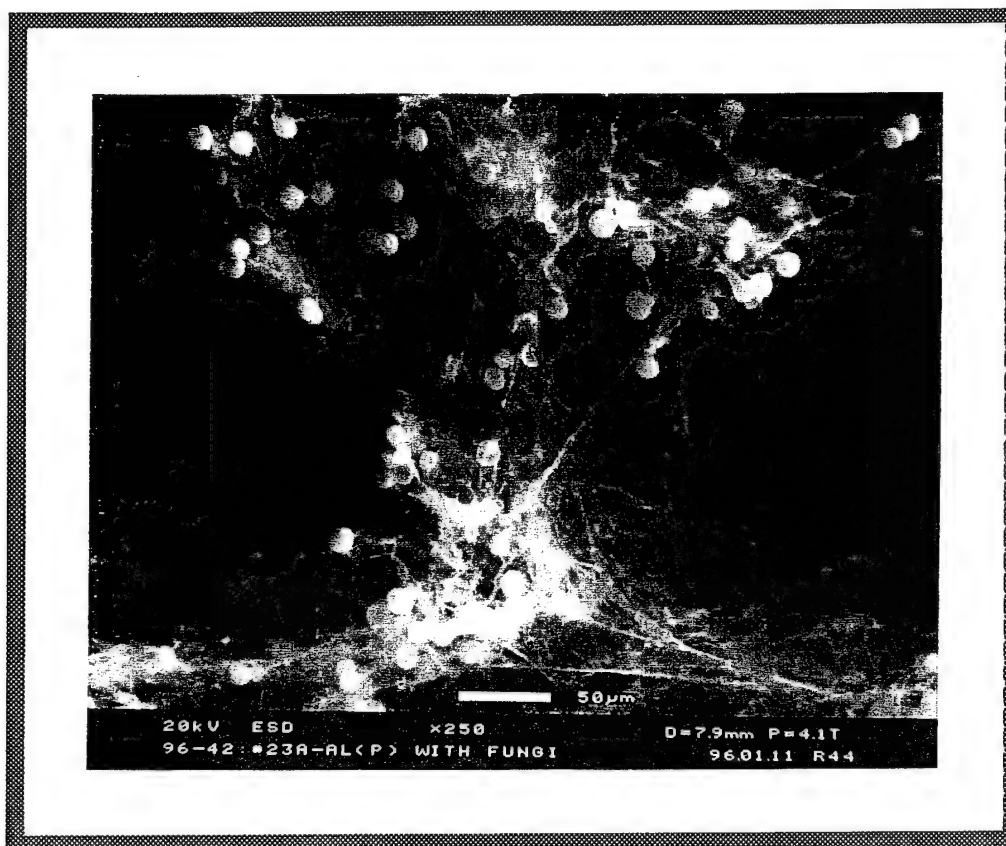
In the ESEM, fungal hyphae were well established on polyurethane surfaces. Figure 8 shows a mycelial mass with conidia, while Figure 9 shows a germinating spore. Although hyphae were firmly attached on polyurethane, there was no obvious degradation at attachment points (Figure 10). Field procedures specify swabbing with 100% isopropyl alcohol for disinfecting paint surfaces (NAVAIR 01-1A-509, T.O. 1-1-691, TM 1-1500-344-23, Aircraft Weapons Systems Cleaning and Corrosion Control). In this study, 75% ethyl alcohol was substituted as an equivalent disinfectant/cleaner. Figure 11 indicates that not all fungal structures were removed by the simulated field cleaning procedure, but remaining fungi would be expected to be non-viable due to the biocide activity of alcohol.

Figure 8: Mycelial mass on polyurethane coated coupon after 30 days (250x).

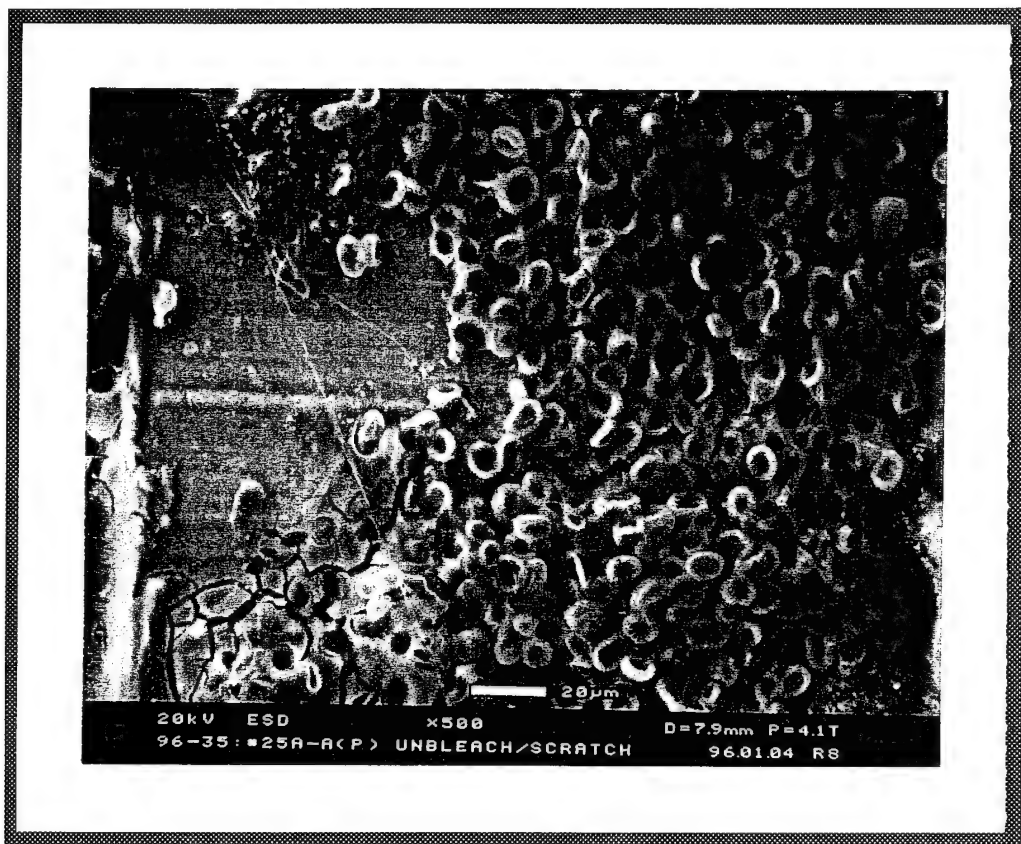
Fungi were present in the unbleached half of the scratches on many coupons, along with occasional corrosion products (Figure 12). Hyphae were also present on the bleached half of the scratches where corrosion was heavy (Figure 13), but corrosion was attributed to oxidation by sodium hypochlorite.

The mechanism for such an effect was not investigated, but Videla (1986) concluded that *Cladosporium* enhanced corrosion of aluminum by producing acidic metabolic products. There is some evidence from ESEM microscopy (Figure 12) that fungi were physically associated with corrosion products formed on aluminum exposed in scratches made in the protective coating. Paint defects are to be expected during the normal duty cycle of military helicopters and may be particularly vulnerable.

Figure 12: Fungal spores in scratch exposing bare metal, unbleached portion. Note hyphae at 11 o'clock and corrosion at 7 o'clock. (500x)

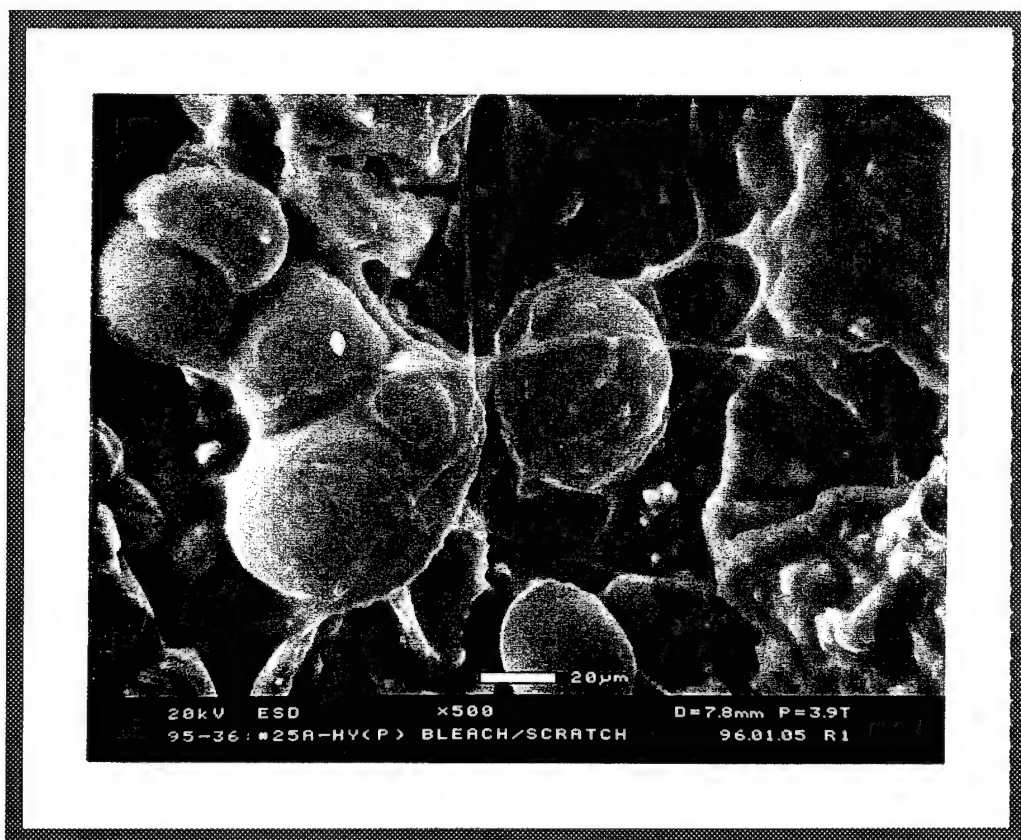
Figure 13: Hyphae on corrosion product in bleached portion of scratch (500x).

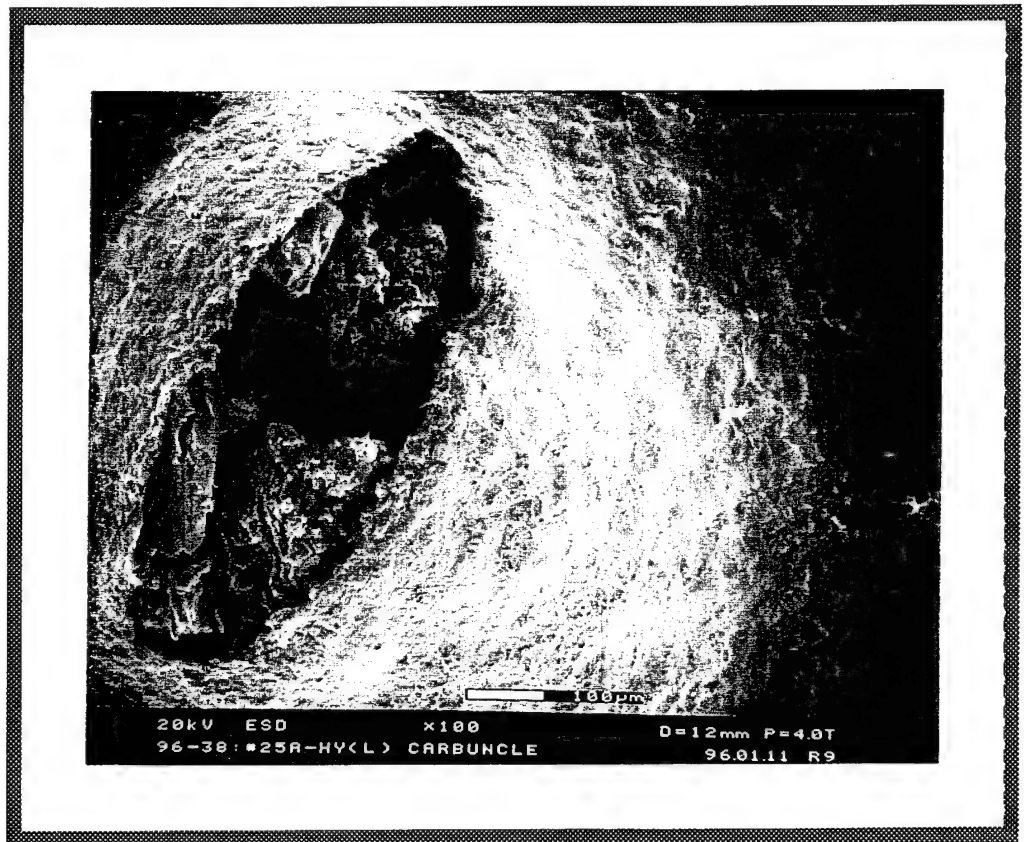
No corrosion or blistering occurred on polyurethane-coated coupons; however, a few blisters were observed on lacquer-coated coupons, mostly close to the central scratch. Although there were few signs of fungi inside the blisters (Figure 14) blister sides were covered with fungal mycelia (Figure 15).

Figure 14: Blister with corrosion on lacquer paint (100x).

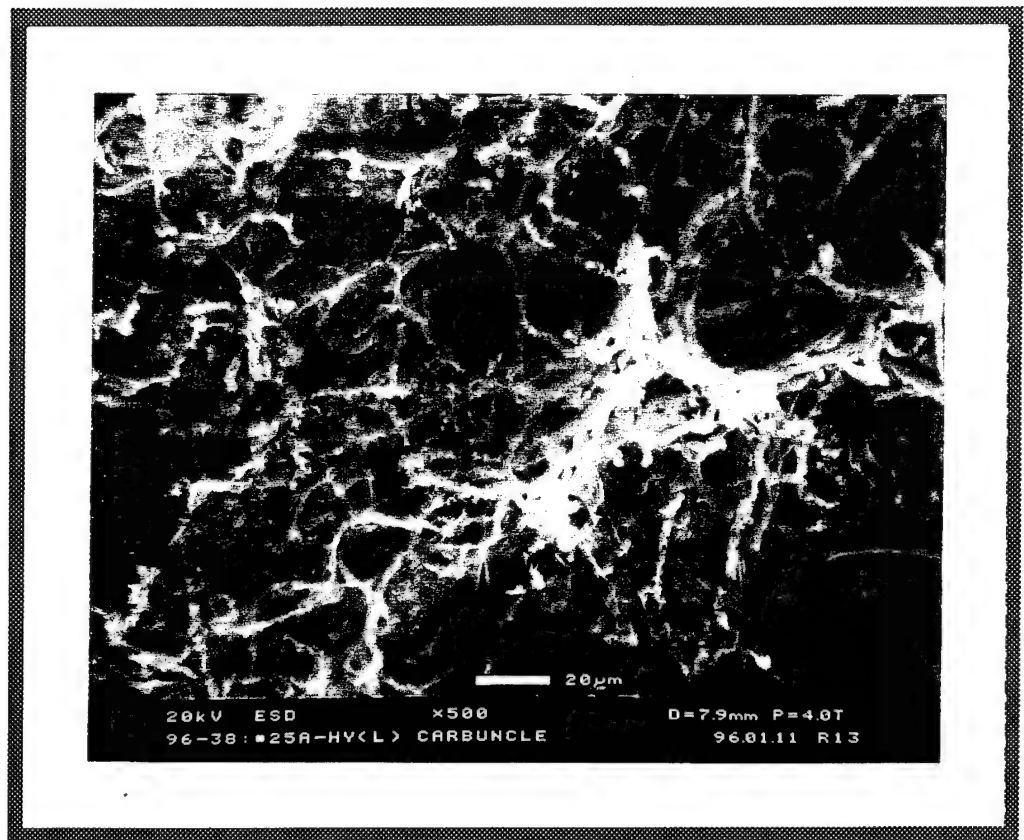
Figure 15: Fungal mycelia covering sides of blister in Fig. 14 (500x).
